# Bridge Inspection Report

**150100AA0188001**  
**PATTERSON STREET**  
**over**  
**MEDINA RIVER**

**Inspection Date:** 11/02/2023

**Inspection Type(s):** Underwater

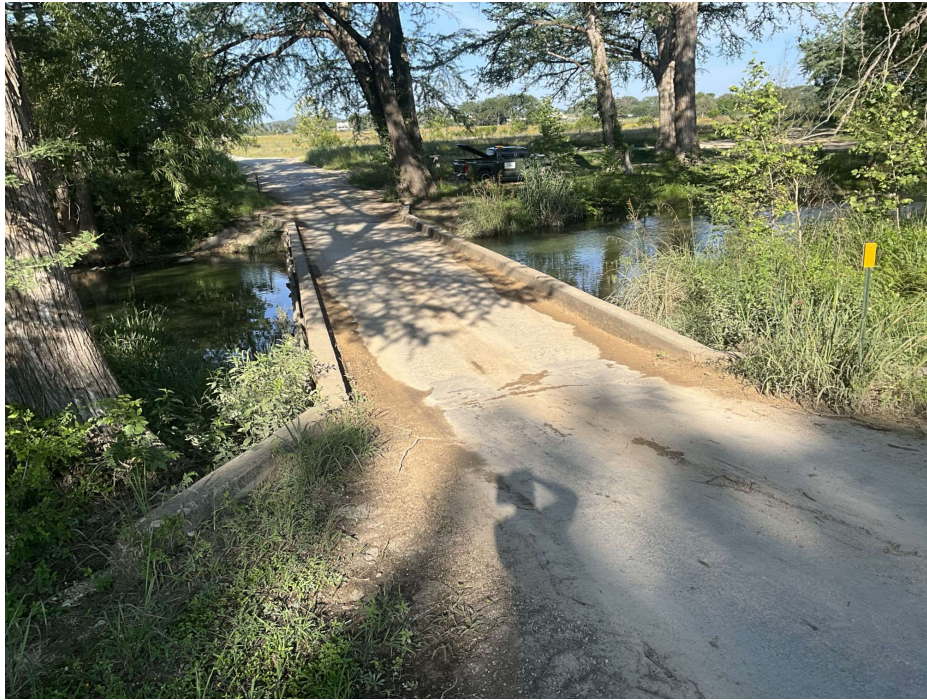
PHOTO 1 Recommended Maintenance Needs

Object markers are missing at East and West corners.  
 Recommendation: Install standard delineation/object markers at bridge corners.

Description 15-010-AA01-88-001 VIEW 10 - MISSING OBJECT MARKERS AT EAST AND WEST CORNERS

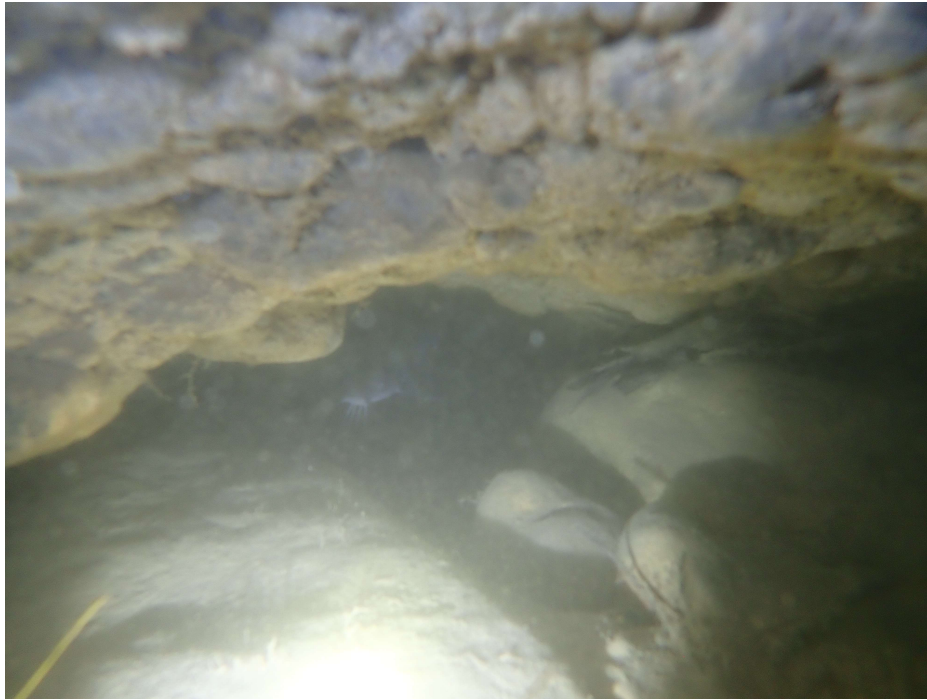
PHOTO 1 Defect

Description Bent 3 footing undermining

Bent 3, East Side of footing is exposed the entire length of 15', and midspan of footing is undermined 4' wide, up to 10" tall, and 40" deep (full width of the footing).

Bent 3, West Side of footing is exposed the entire length of 15', and midspan of footing is undermined 6' wide, up to 12" tall, and 40" deep (full width of footing).

Mitigate undermining at Bents 2 , 3 and 4 footing .

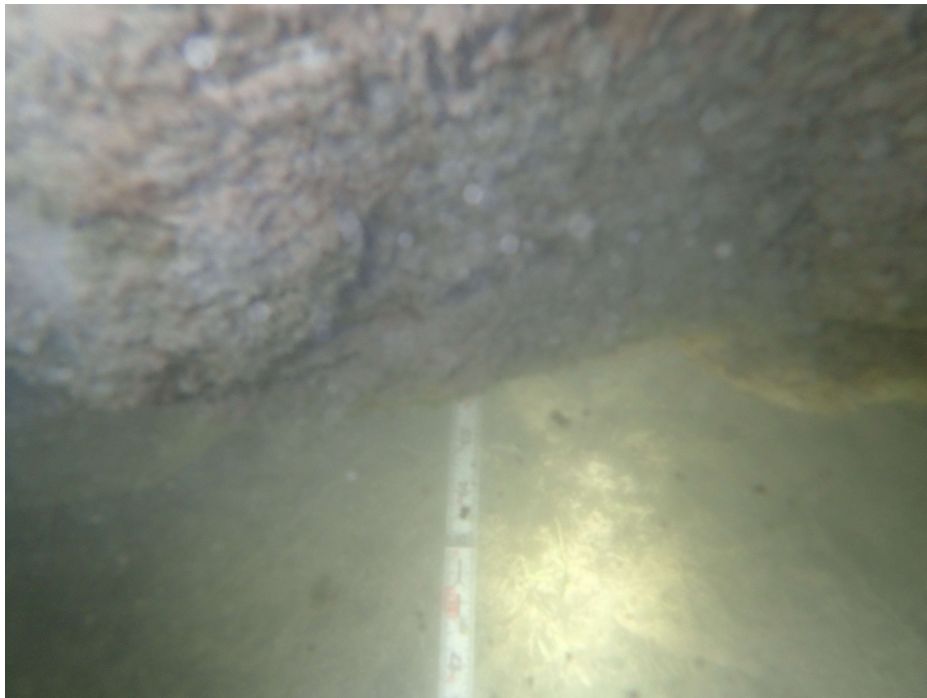
PHOTO 2 Defect

Description Bent 2 footing, West Side, undermining 14" deep

Bent 2, West Side of the footing is exposed the entire length of 15', with undermining that starts 5' from the North End and measures 3' wide, up to 2" tall, and up to 14" deep.

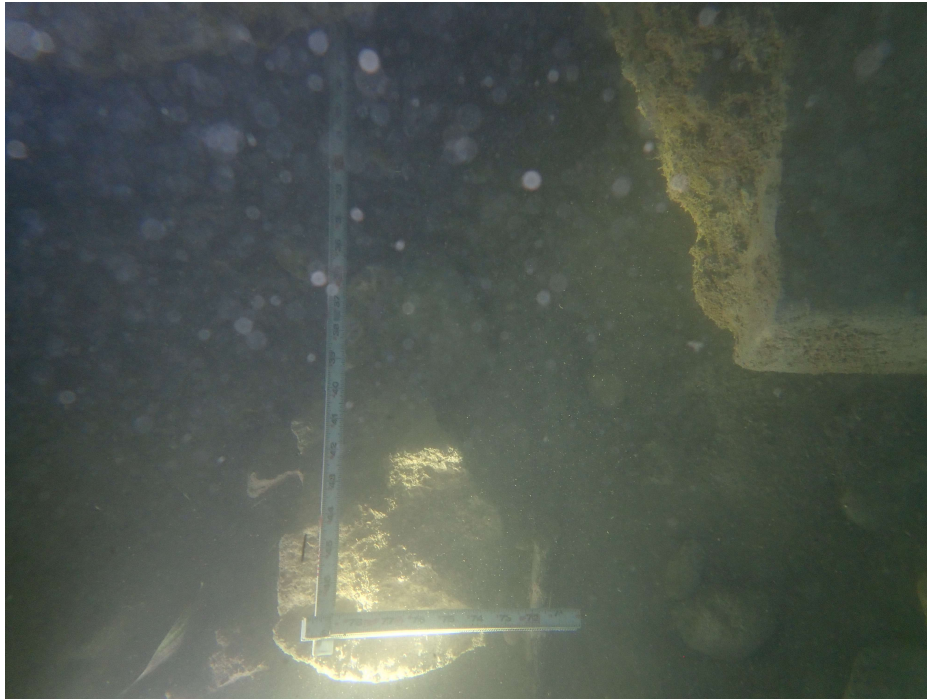
PHOTO 3 Defect

Description Bent 4 footing, East Side, undermining up to 40" out to edge of footing (full width of the footing)

Bent 4, East Side of footing is exposed the entire length of 15', and 5' from the South End there is undermining 10' wide, up to 13" tall, and 40" deep (full width of footing). There is also a 30" long section of the footing here that is broken off flush with the pier wall.

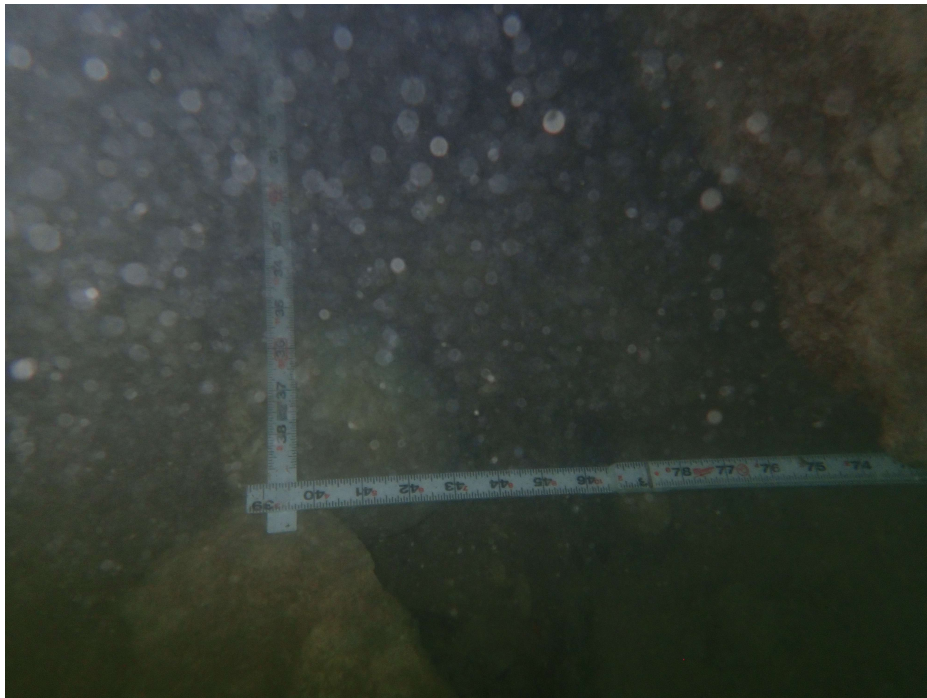
PHOTO 4 Defect

Description Bent 4 footing, East Side, undermining up to 40" out to edge of footing (full width of the footing)

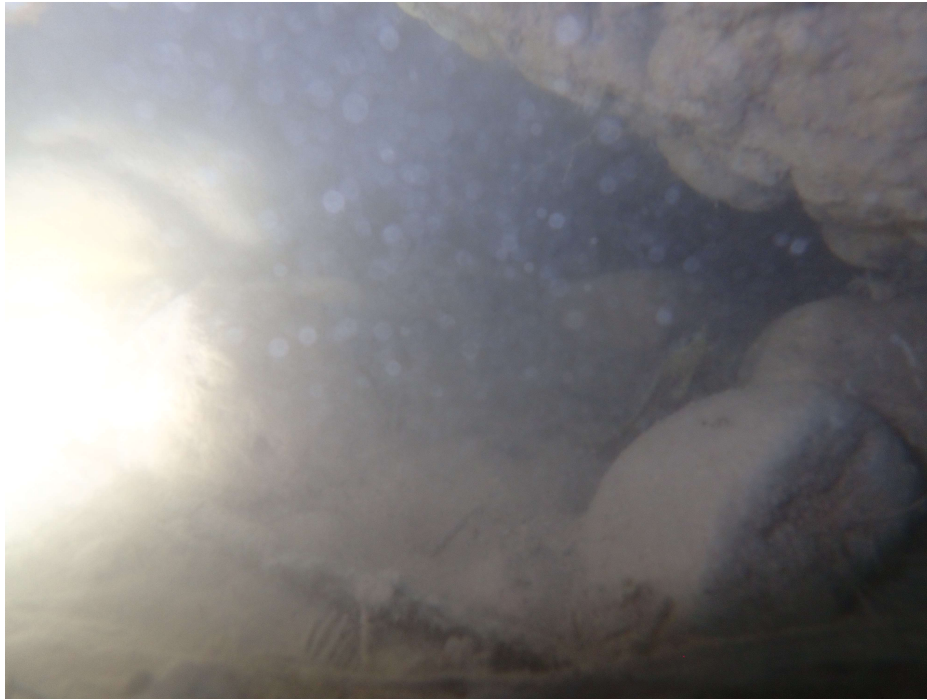
PHOTO 5 Defect

Description Bent 4 footing, East Side, undermining

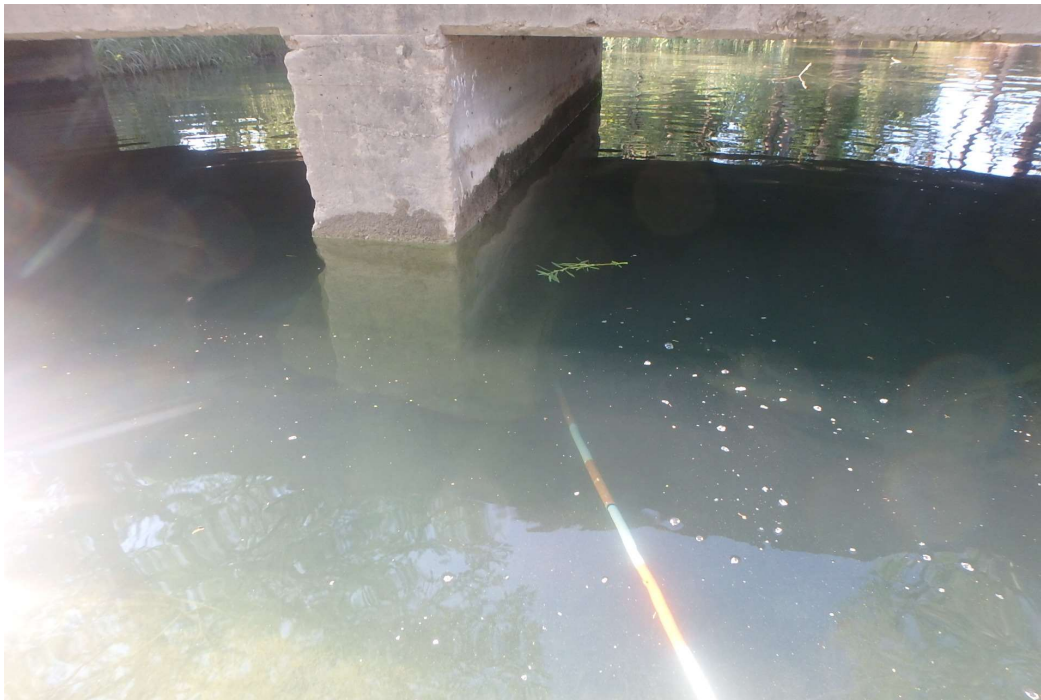
PHOTO 6 Recommended Maintenance Needs

Description 15-010-AA01-88-001 VIEW 9 - UNDERMINING AT UPSTREAM END OF PIER WALL AT BENT 3 FROM NE

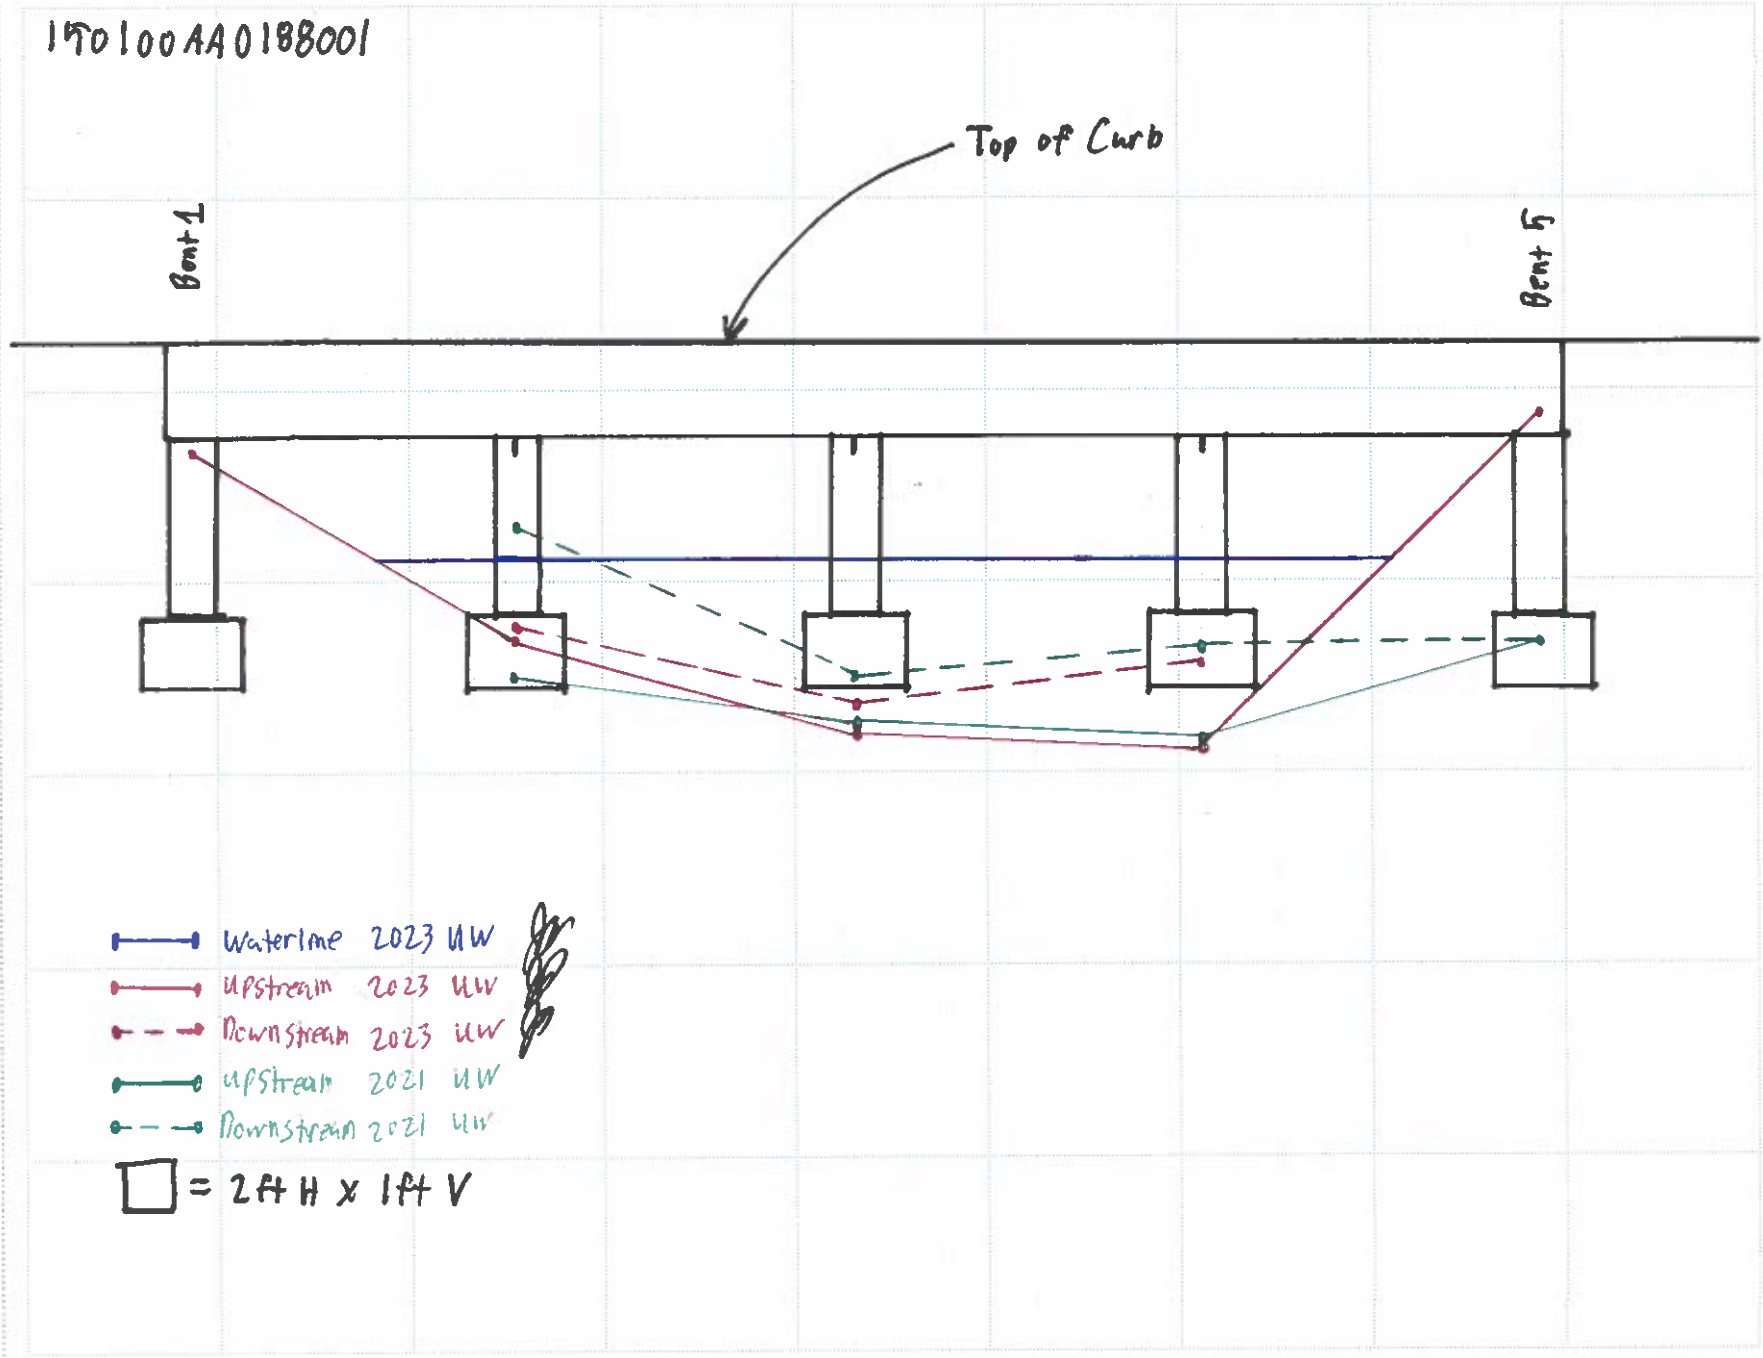
Comments:  
PROFILE TAKEN USING LEADLINE ON UPSTREAM AND DOWNSTREAM SIDES.

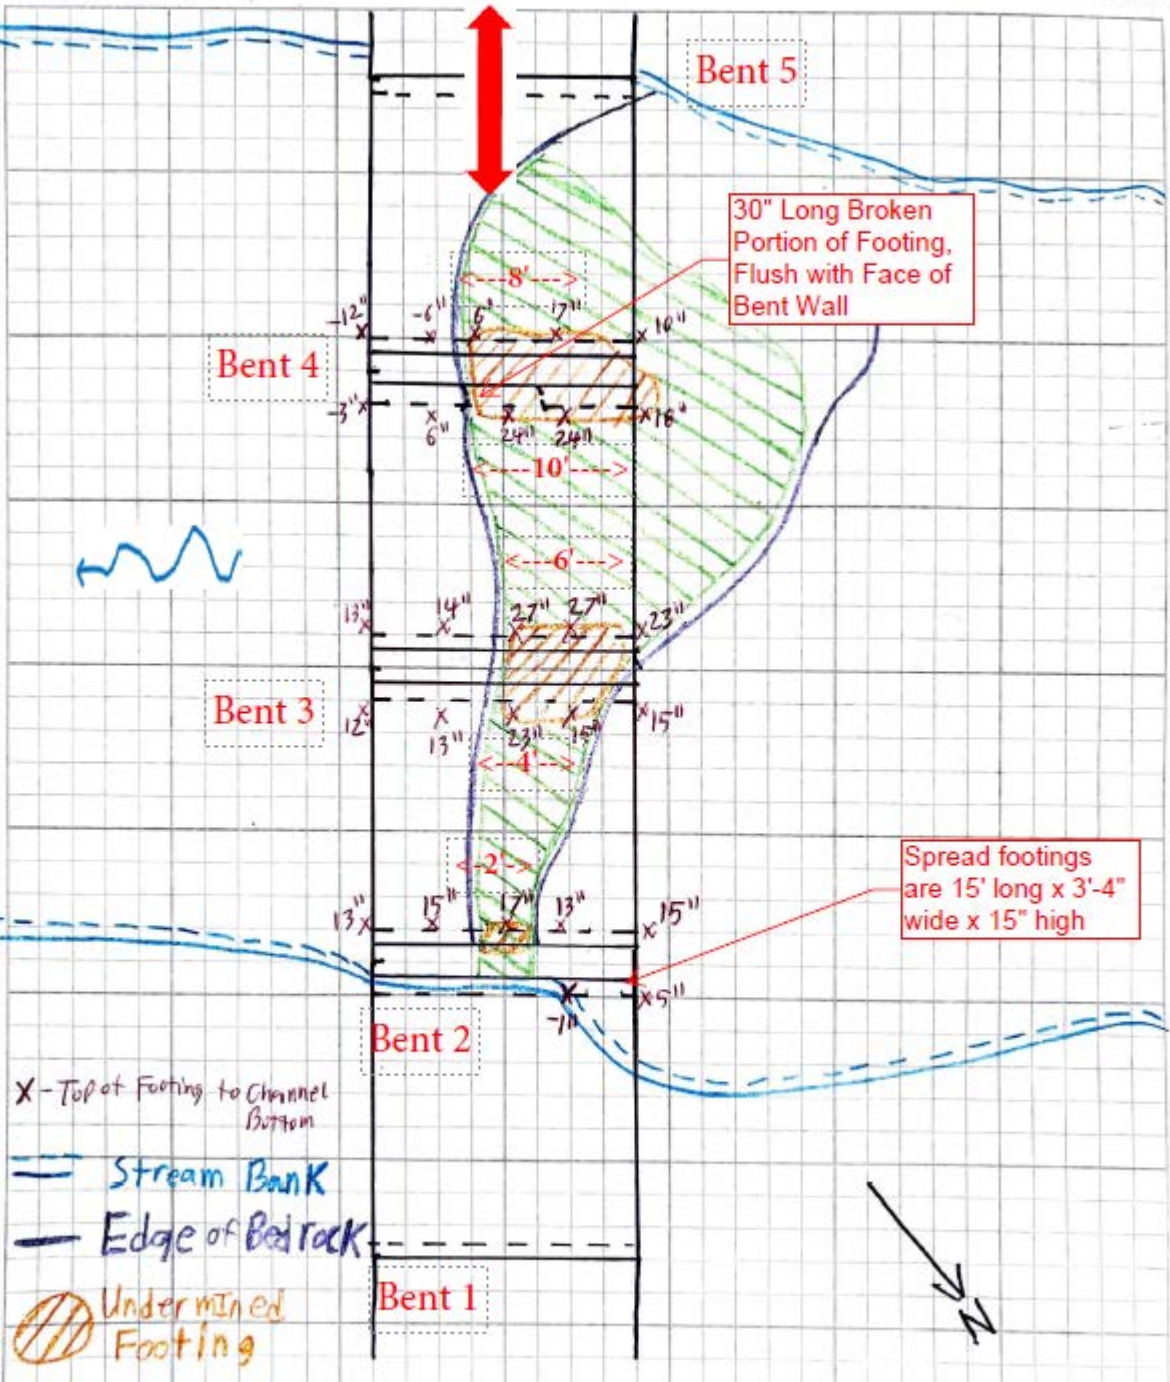
The 24-month UW inspection performed on 11/3/2023 discovered that spread footings at Bents 2, 3, and 4 from the NE are undermined approximately 5%, 33%, and 60%, respectively. See sketch. This has increased from the previous inspection. Item 113 - Scour will be changed to "1" for major observed scour. This coding dictates that Item 60 - Substructure, also be coded "1".

30" Long Broken Portion of Footing, Flush with Face of Bent Wall

**Comments:** Permanent repairs should consist of reestablishing bearing below the spread footings. (It is approximately 1' from the bottom of spread footings to bedrock.)
