ADDENDUM NO. 2

DATE: January 27, 2025
RE: Architect's Project #: 2301 A1
Project: **Bandera County Visitor Center
Phase 2 – Historic Stabilization**
FROM: Fisher Heck, Inc., Architects
915 South St. Mary's Street
San Antonio, Texas 78205
(210) 299-1500
TO: All Plan Holders

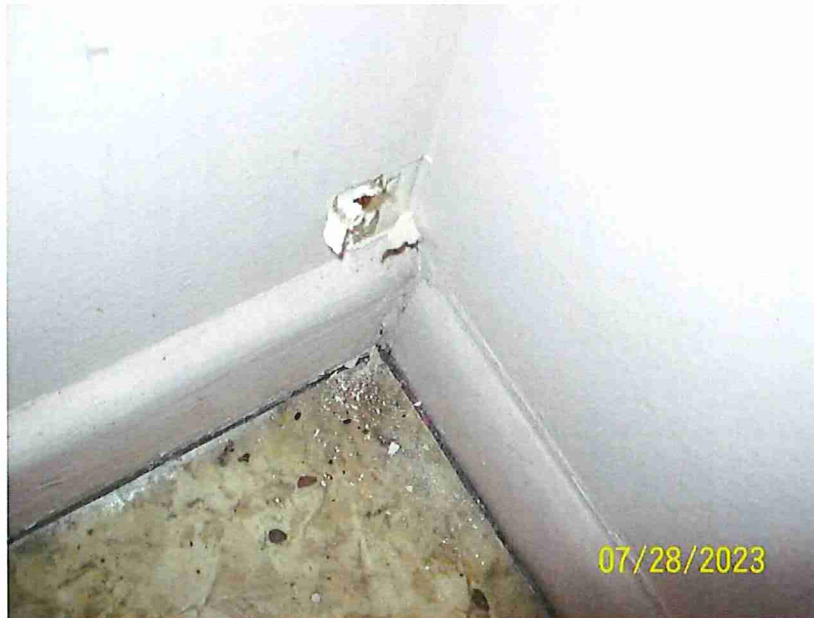
4. View of Typical **Positive** Wallboard with Joint Compound

The wallboard sealed & joint compound, linoleum, 12x12 inch vinyl tile and felt paper under carpet ***must*** be removed prior to any operations that may disturb the asbestos fibers in the material. Abatement must be accomplished according to the guidelines set forth in 40 CFR 61, the National Emission Standard for Hazardous Air Pollutants (NESHAP) and/or DSHS, Texas Asbestos Health Protection Rules, March 2003. This includes removal by a licensed asbestos abatement contractor and project management by a licensed asbestos consultant firm.

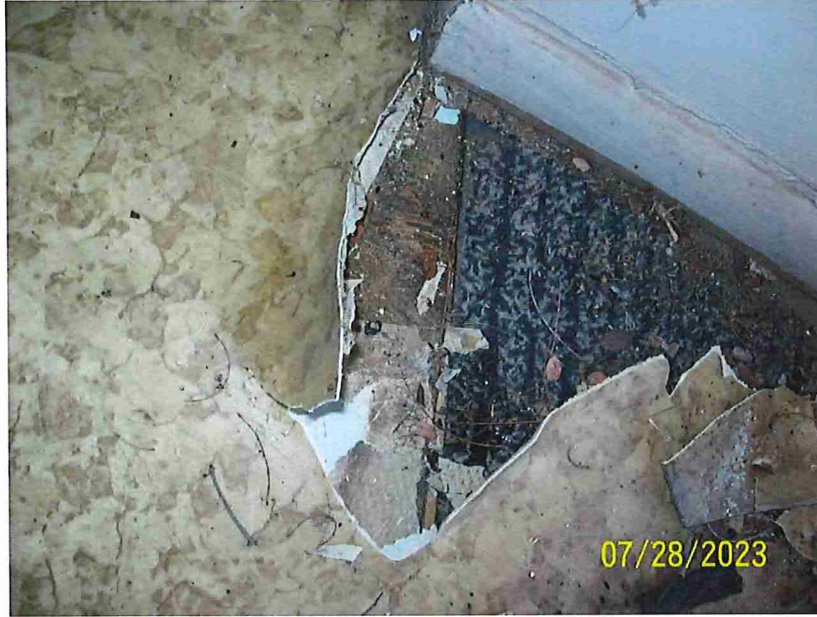
5. View of **Positive** Linoleum in Front Entry

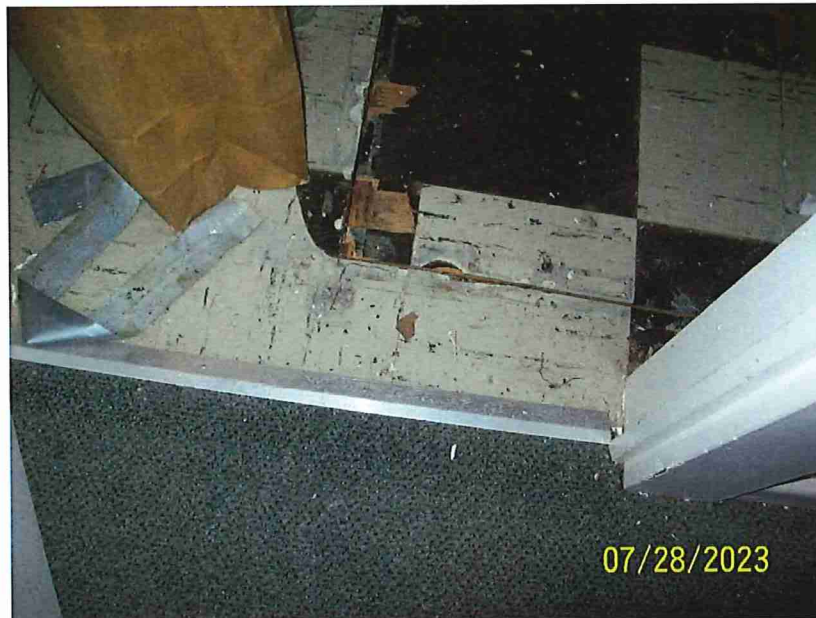
8. View of **Positive** Vinyl Tile with Black Felt Paper under Carpet

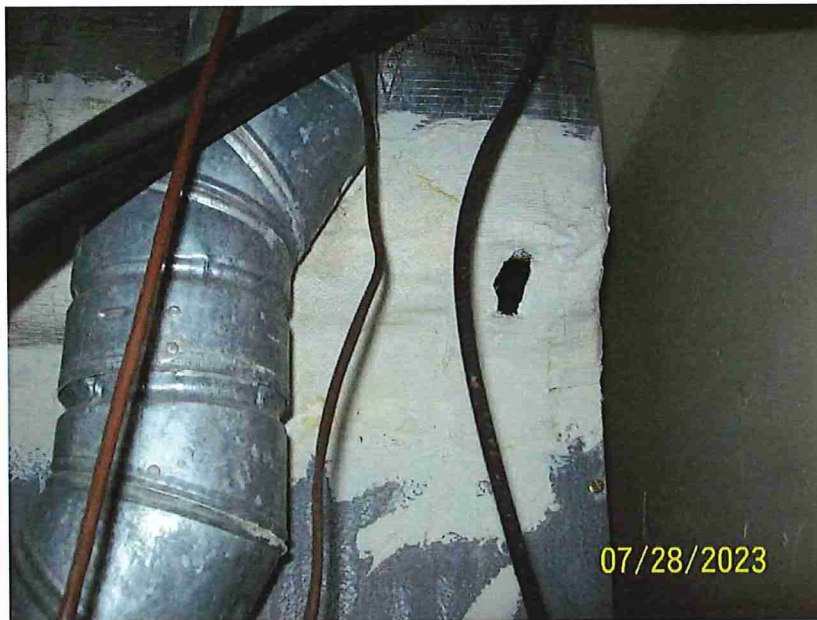
10. View of White Mastic on HVAC Unit

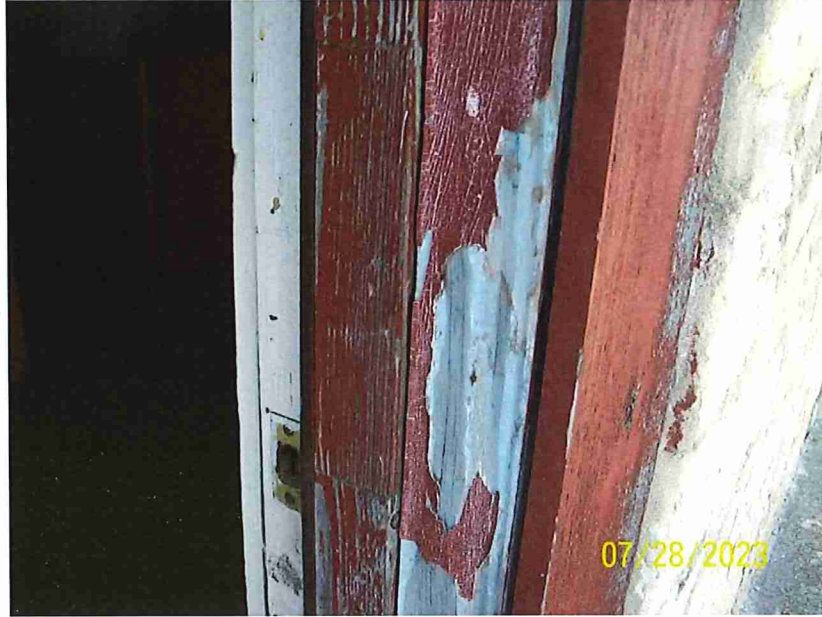
13. View of Red Painted Door Frame

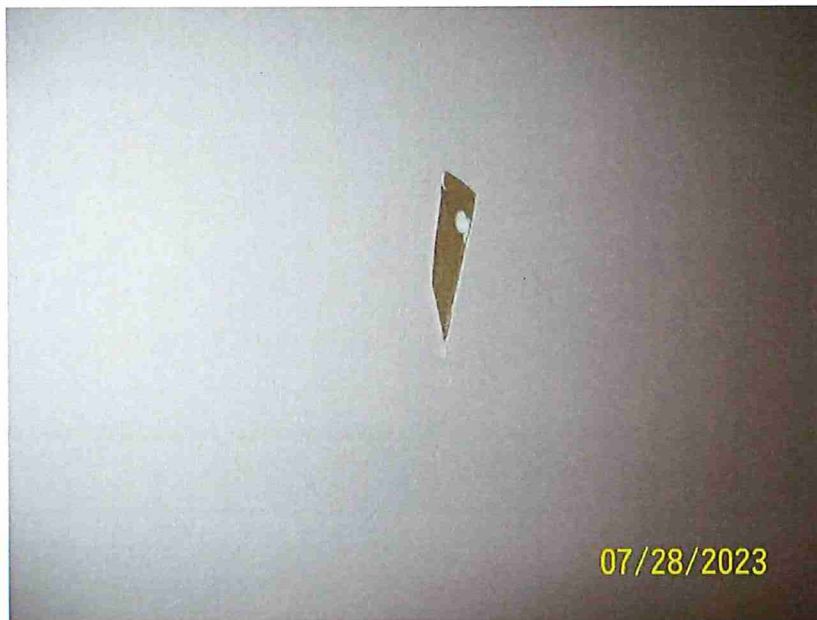
14. View of Tan Painted Wall

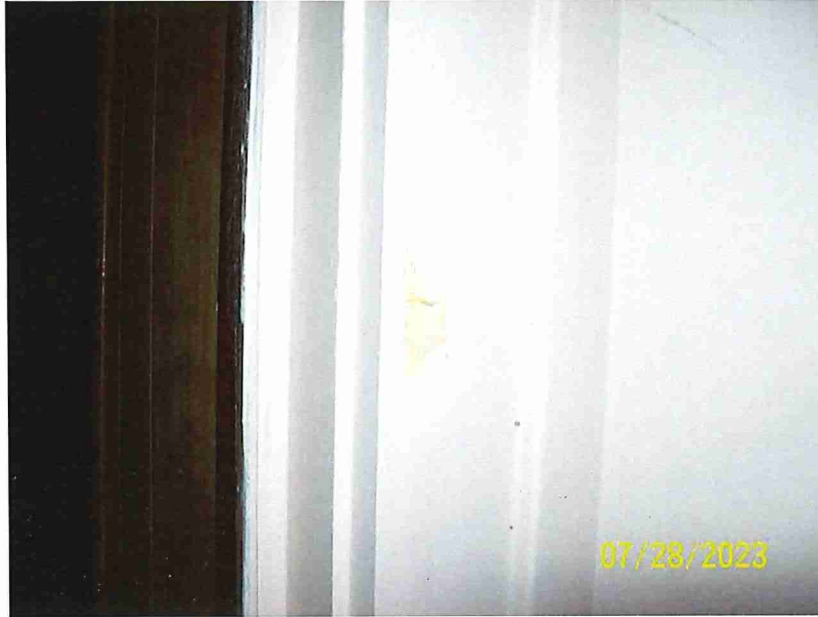
15. View of White Painted Door Frame

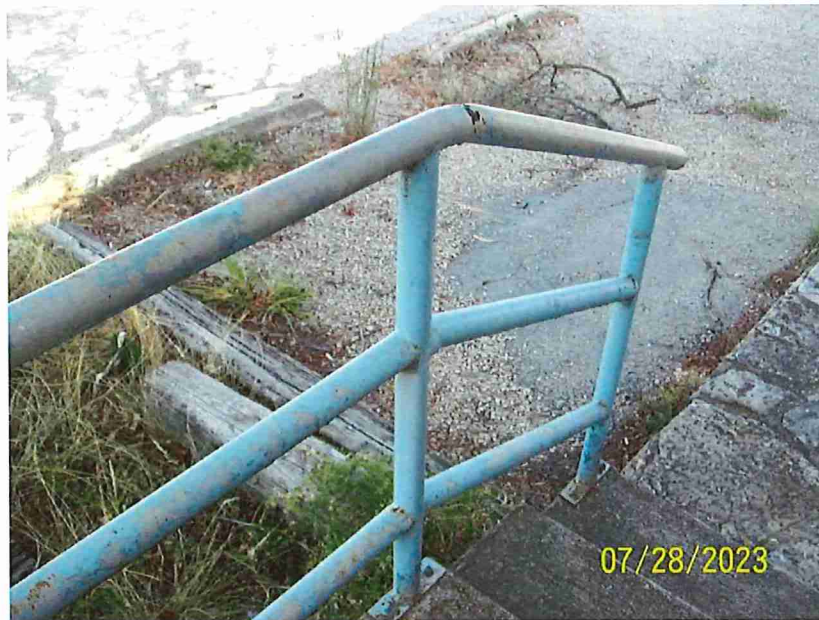
16. View of Blue Painted Railing

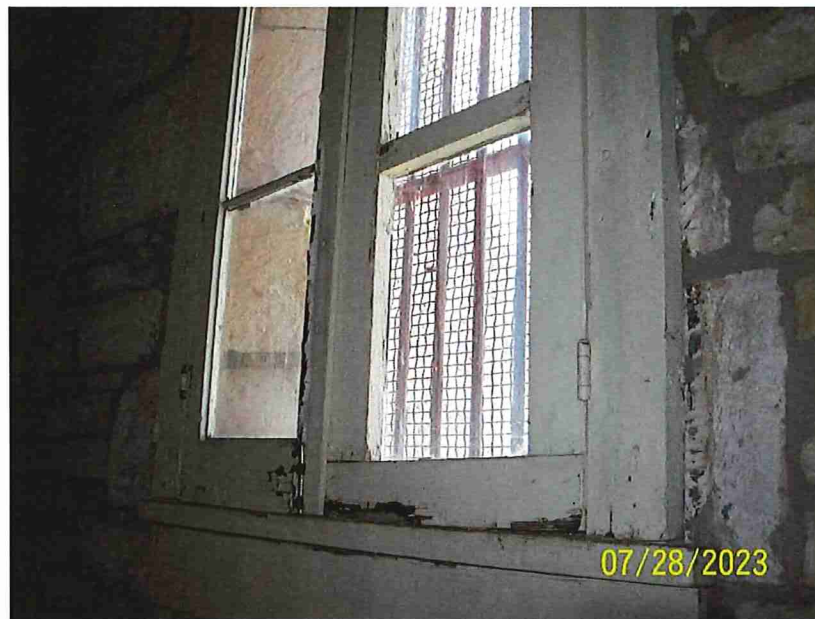
8. View of Tan Painted Windows
